Town of Arlington

DRAFT REPORT

ADA Self-Evaluation (as basis for Transition Plan)

Prepared by
Institute for Human Centered Design
September 15, 2014

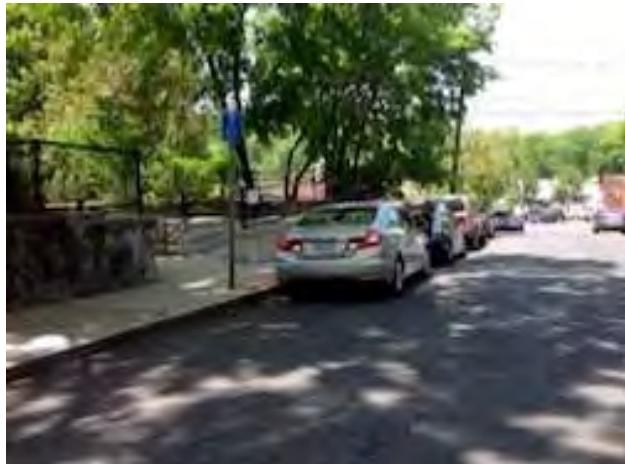
Photo 4

There is 1 designated accessible parallel parking space outside Park entry. There are some excessive cross slopes on sidewalk between parking space and Park entryway. There is no curb ramp along this mid-sidewalk location. (Photo 4)

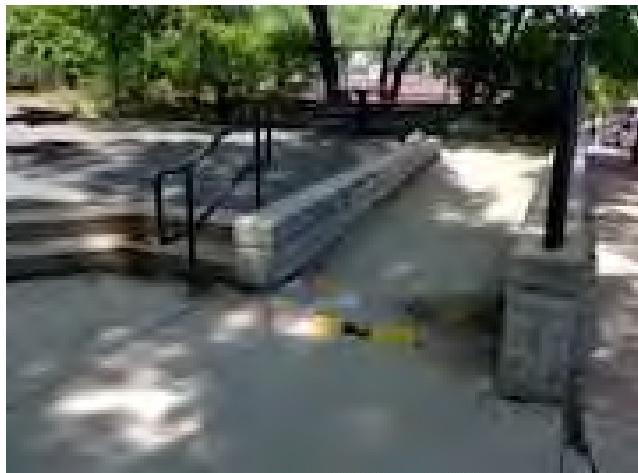
Photo 5

Facility has one entrance. There is a friendly foyer-type presentation leading to a two-step staircase on the left, and a matching accessible ramp to the right. (Photo 5)

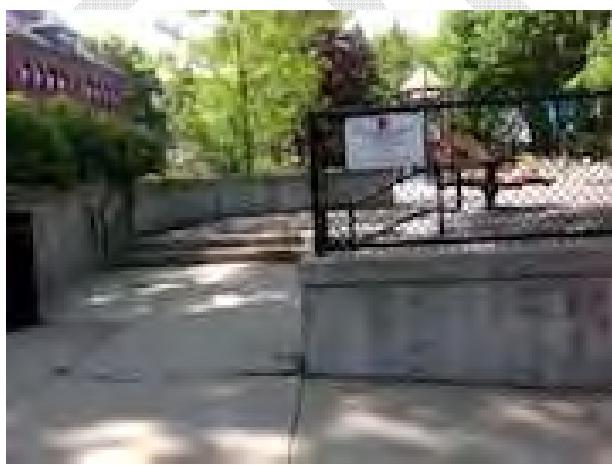
Photo 6

Entryway panels have some minor cross slope issues. (Photo 6)

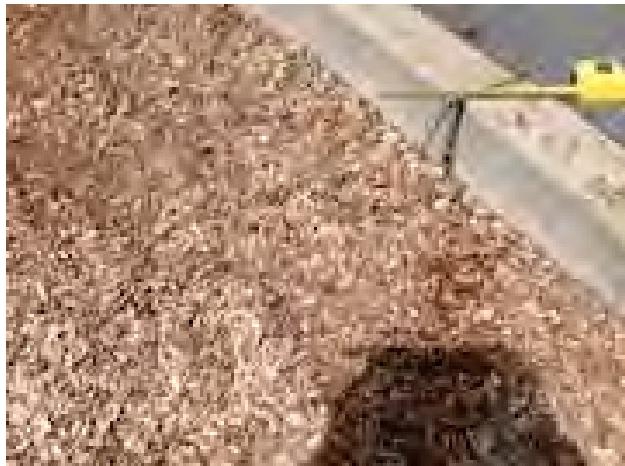
Photo 10

There is not yet an accessible, level connection between the ground surface of the recessed play areas and the adjacent cement walkways due to the high borders around the compacted loose fill surfaces. (Photo 10)

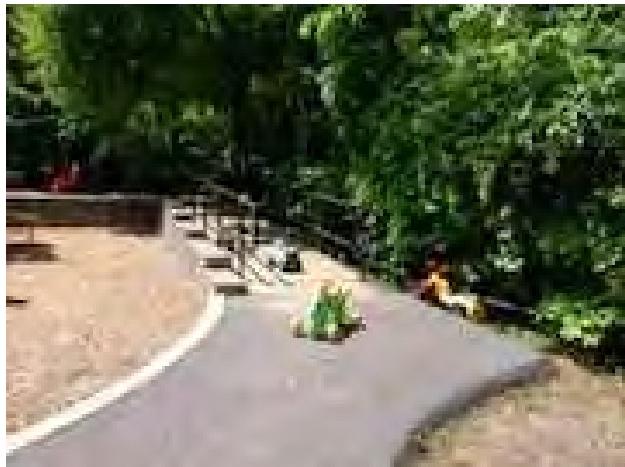
Photo 11

The lack of a level entry/exit into the recessed play areas on both levels prevents an accessible route connecting the bottom and top of the slides, despite the walkway ramp connection just out of level reach. (Photo 11)

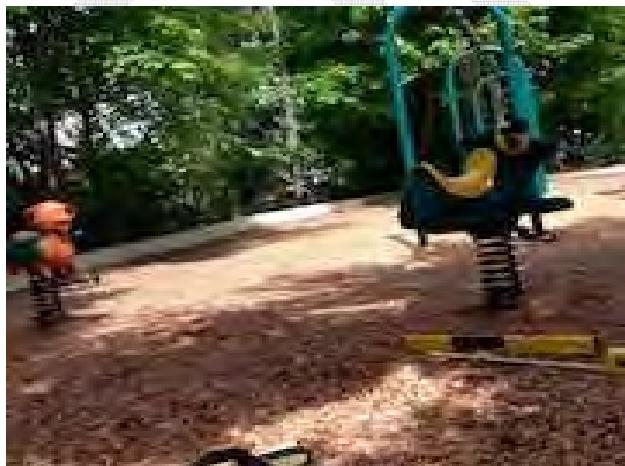
Photo 12

The loose fill ground surface materials are not currently providing accessible slopes and firmness; although they may be providing adequate impact attenuation conditions. (Photo 12)

a. If loose fill ground surface materials are still used, a high-frequency maintenance policy needs to be implemented to ensure accessible routes in recessed play areas through all seasons.

b. If ground surface materials will be replaced: consider resurfacing all or portions of the recessed play areas with unitary surface materials that are resilient and also provide accessible levels and firmness.

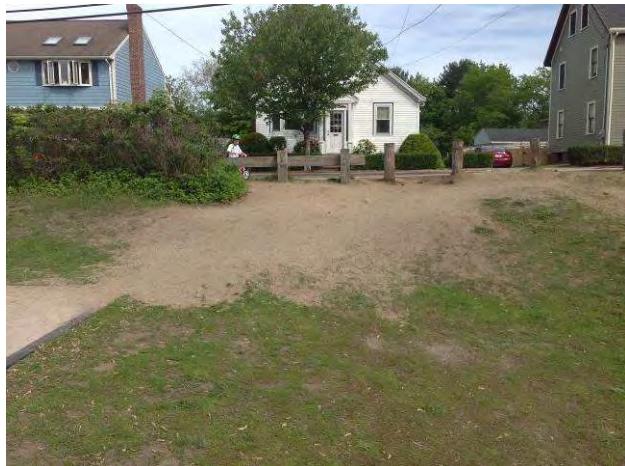
Photo 1

Due to the lack of another option, the walkway leading to the playground on North Union Street has been used by the public as a *de facto* point of entry to this facility. (Photo1)

- 1 Points of Entry:** While a section of this facility is closed for renovations, provide a temporary accessible point of entry on North Union Street. At each stairway leading to the fields, install an ADA-compliant sign directing the public to the accessible point of entry.

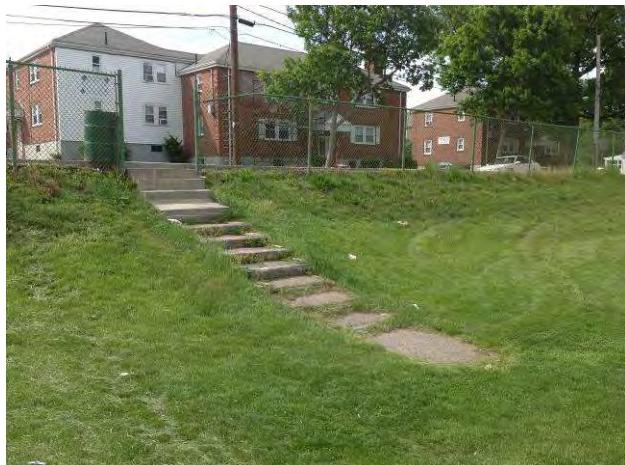
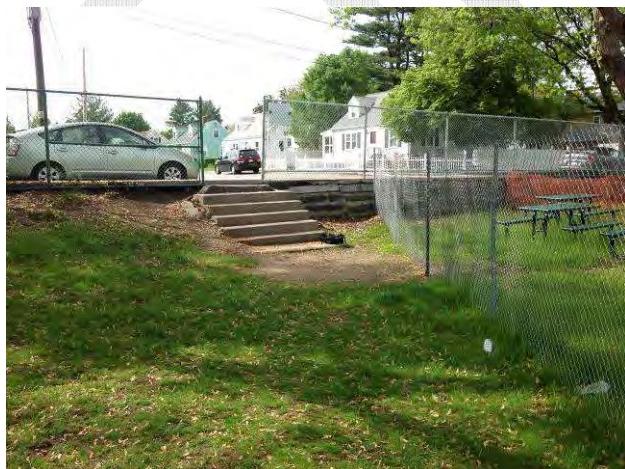
Additionally, neither of the stairways on North Union and Everett Street have compliant railings on both sides. (Photos 2 and 3)

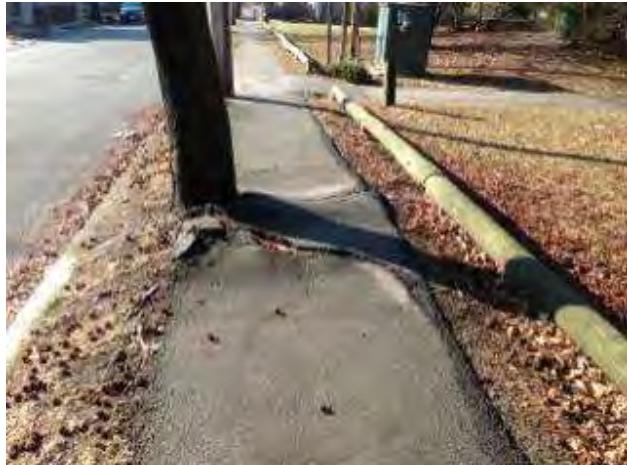
Photo 2

Although the sidewalks along Herbert Road and the Minuteman Commuter Bikeway are mostly accessible, the sidewalk along Thorndike Street is in poor condition. Not only are a few sections near trees extremely deteriorated but also the sidewalk has excessive cross slopes. (Photo 2)

Repair the sidewalk along Thorndike Street (about 300 feet).

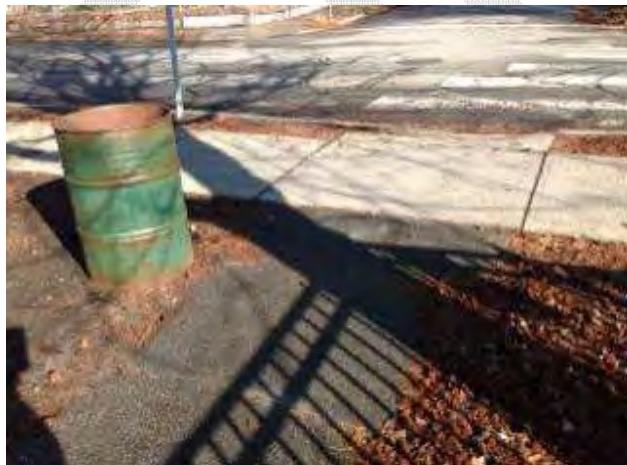
Photo 3

This facility has four at-grade points of entry: two on Herbert Road, one on Thorndike Street, and one along the Minuteman Commuter Bikeway. On Herbert Road and on Thorndike Street, the asphalt walkways at the edge of the sidewalk have excessive slopes (15.5% and 14%, respectively). (Photo 3)

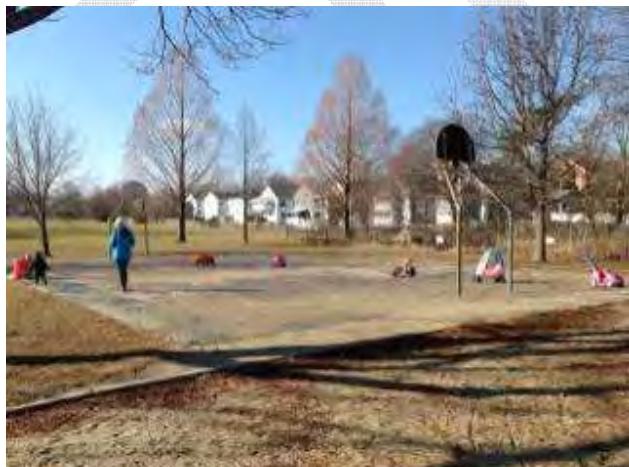
Photo 6

Although an asphalt walkway is provided between the points of entry and certain features in this facility, no accessible route is provided between the asphalt walkway and the basketball court. (Photo 6)

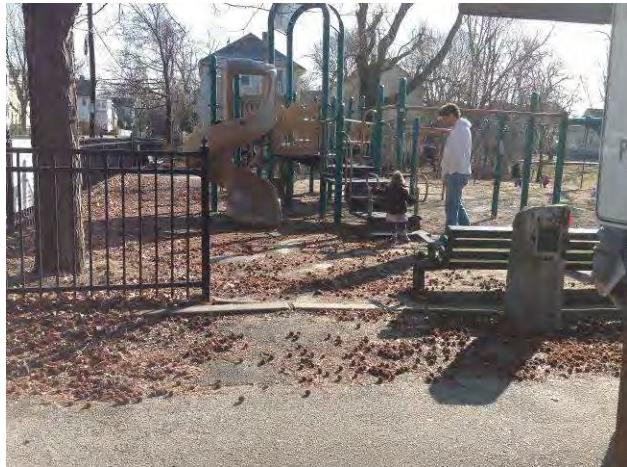
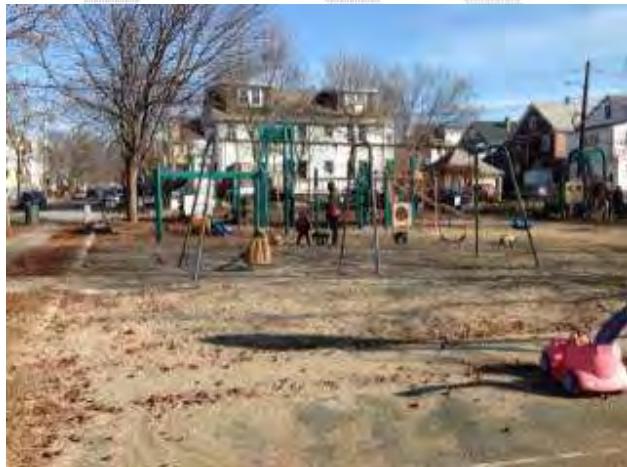
One large sandy area contains separate zones of play structures. Although an accessible route is provided to the small play structure on Herbert Road and the swingset adjacent to the asphalt walkway, no accessible route is provided to the rest of the playground. (Photos 8 and 9)

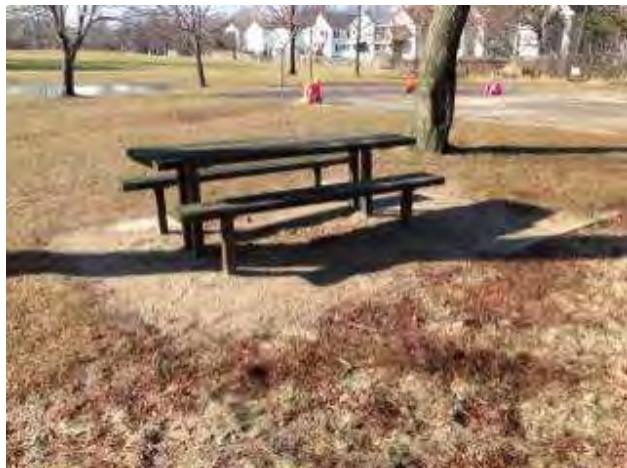
Photo 10

One picnic table is provided near the playground; however, it is not accessible because it does not provide the required knee clearance for wheeled mobility devices and is not provided on an accessible route. (Photo 10)

Replace the picnic table near the playground with an ADA-compliant amenity and extend the asphalt walkway to it (about 75 feet).

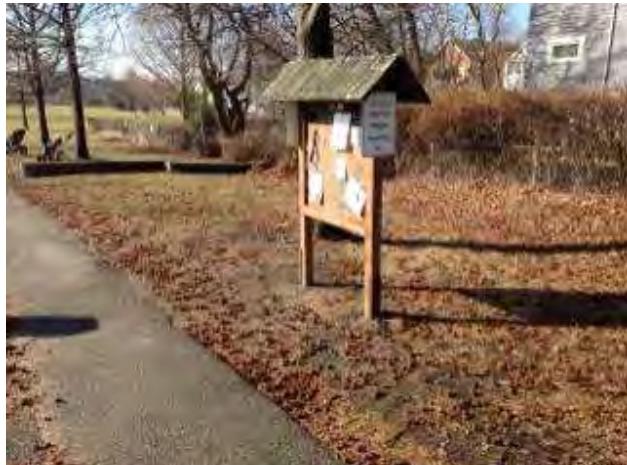
Photo 11

A bulletin board is provided near the point of entry at Herbert Road; however, it is not located within an accessible route. (Photo 11)

- 10 Bulletin Board:** Although not a requirement under the ADA, consider extending the asphalt walkway to the bulletin board.
- 11 Community Garden:** Completely re-configure the community garden so that accessible routes as well as planter beds at an accessible height and other features are provided within the garden.

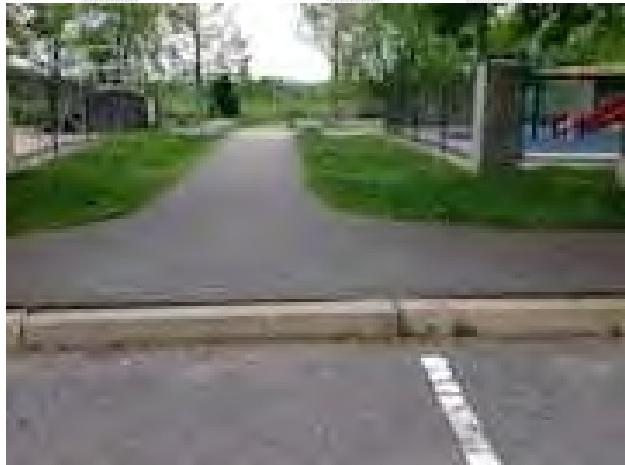
Photo 3

Sidewalks around the first parking facility are in good condition, but the smooth asphalt ground surface materials stop at the crossing between the skateboard park and playground. At this crossing and leading further into the grassy areas, the ground surface materials are embedded small cobblestone brick and stone dust. (Photo 3)

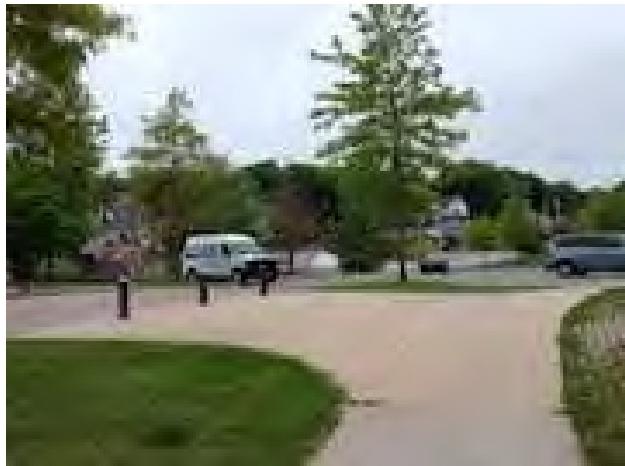
Photo 4

There are two parking areas separated by a large brick-paver surface speed bump.
(Photo 4)

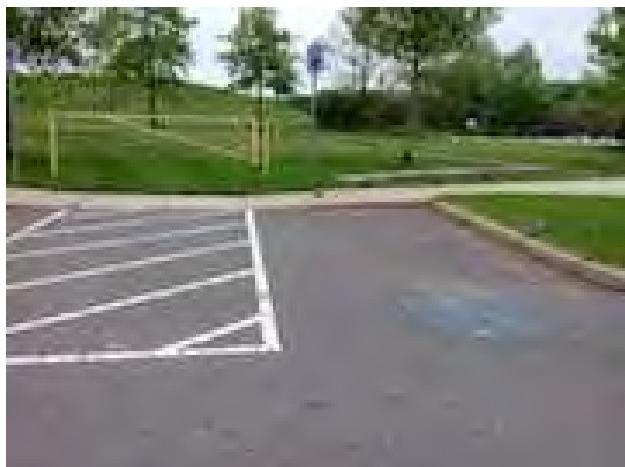
Photo 5

The interior walkway leading to the sitting area between the two play areas is the only walkway that provides a continuous accessible route into a facility area; however, this walkway is not connected along an accessible route to the designated accessible parking spaces. (See Photo 5, previous page)

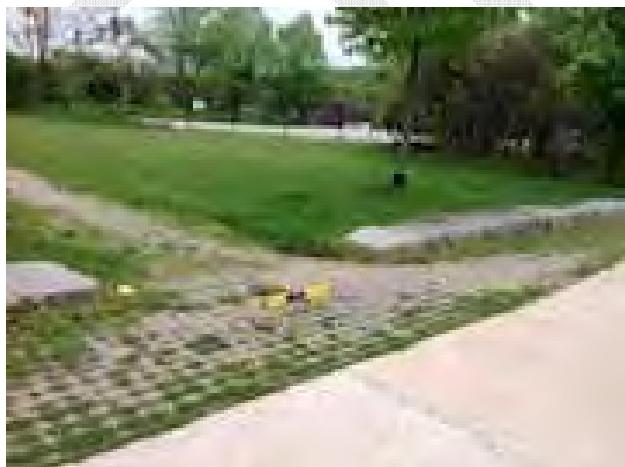
Photo 6

From the parking facility, there are four points of entry into different program areas leading into field walkway, picnic area, between skateboard park and the playground, and to sitting area within playground area. Only the walkway into the playground sitting area is accessible (Photo 6)

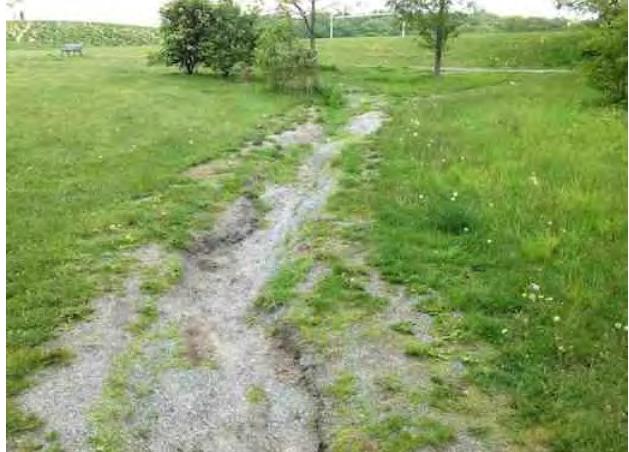
Photo 9

The circulation route around the fields and adjacent to Reed's Brook is uneven. Stone dust paths have eroded and dirt pathways do not hold accessible slopes and are not level. (Photo 9)

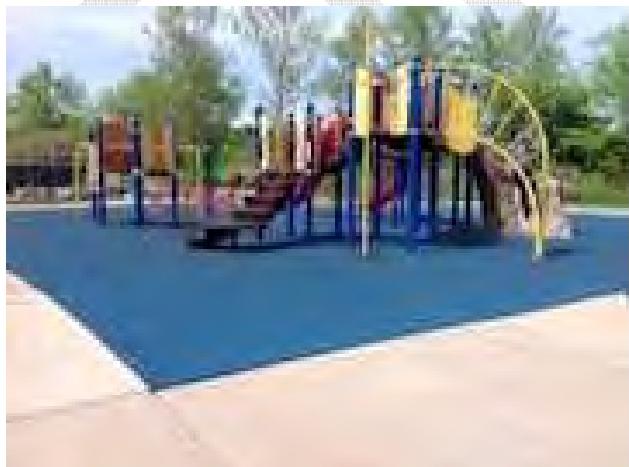
Photo 12

The large play area for older children has at least twenty play components total, and no elevated accessible route. The transfer system requires many steps to reach elevated play components. The trampoline is also accessed by steps or by climbing over the rim, a reach of over one foot. There are not accessible elevated routes to reach the mostly elevated play components. (Photo 12)

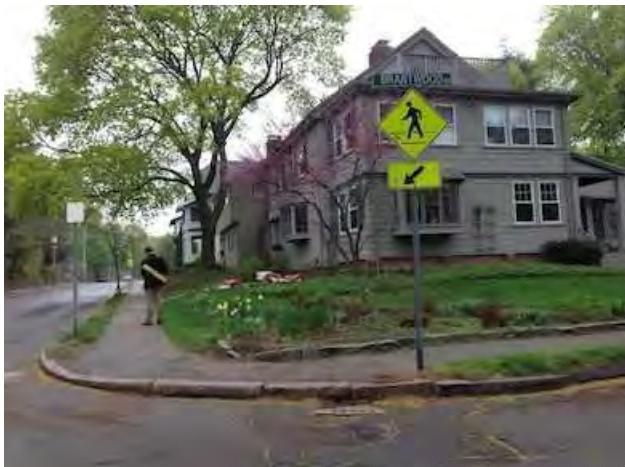
Photo 2

Curb ramps are missing at junction of Brantwood Rd & Jason St. (Photo 2)

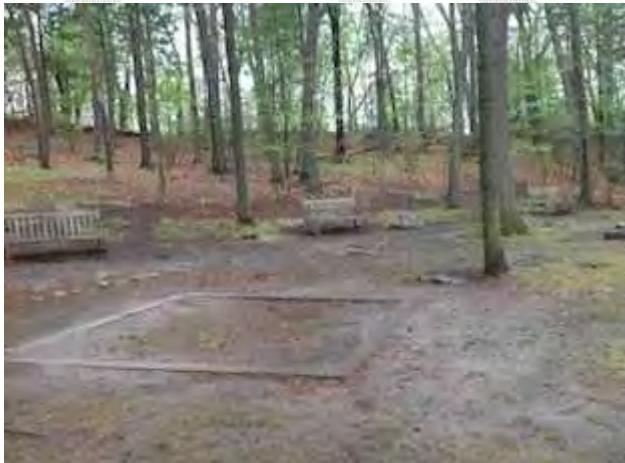
Photo 8

There needs to be at least 1 accessible pathway connection from trail to the picnic area's 2 accessible tables; and in addition, a connection needs to be established between trail and the Woodhenge circle. (Photo 8)

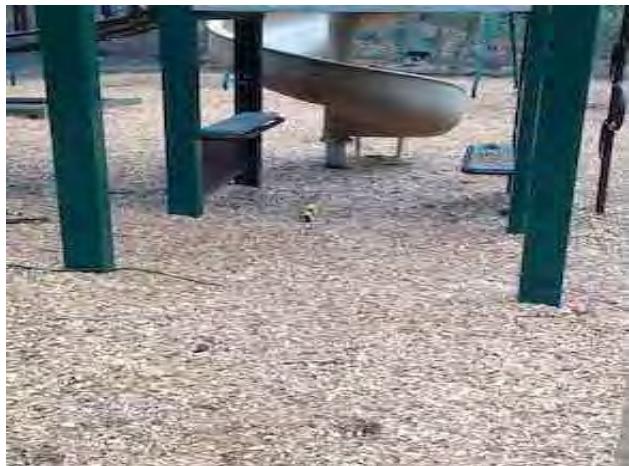
Photo 9

These surface materials may fulfill impact-attenuating requirements, but they are not accessible because ground surface materials show excessive cross slopes and depressions near and within accessible ground play elements. (Photo 9)

- a. If only loose fill ground surface materials are used, implement a high-frequency maintenance program to ensure accessibility of ground surface materials through all seasons.
- b. If ground surface materials will be replaced: consider adding unitary surface materials within the playground areas to provide accessible routes and clear ground spaces to all entry/exit points of ground play elements, including swingsets, play structure transfer station, and ground play elements.

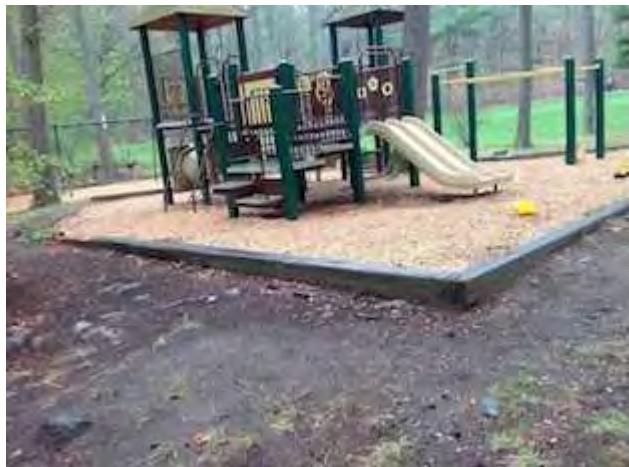
Photo 10

The playground border is a barrier to accessible entry into the play area because it has level changes of between 2 - 8 inches above the trail and there is currently no accessible entry point into the play area. (Photo 10)

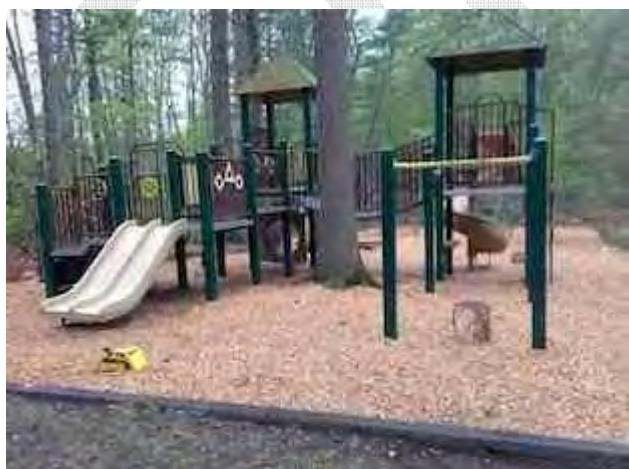
Photo 11

A transfer system provides stepped connection to at least 50% elevated elements, and there is no accessible (ramped) elevated route. (Photo 11)

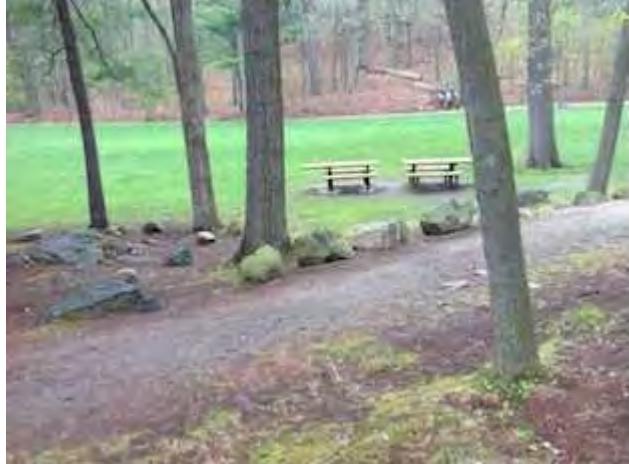
Photo 14

There are two accessible picnic tables provided. These thoughtful tables need to be connected to an accessible path branching off the main graded trail. (Photo 14)

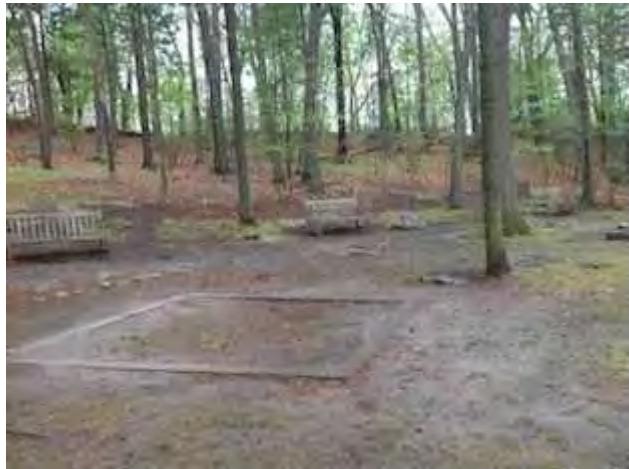
Photo 15

Some wooden benches are not highly visible along the wooded portion of the accessible trail; others, painted green, are easily spotted and along the well graded trail. A best practice recommendation is to repaint faded wooden benches with a color that contrasts with the natural environment.

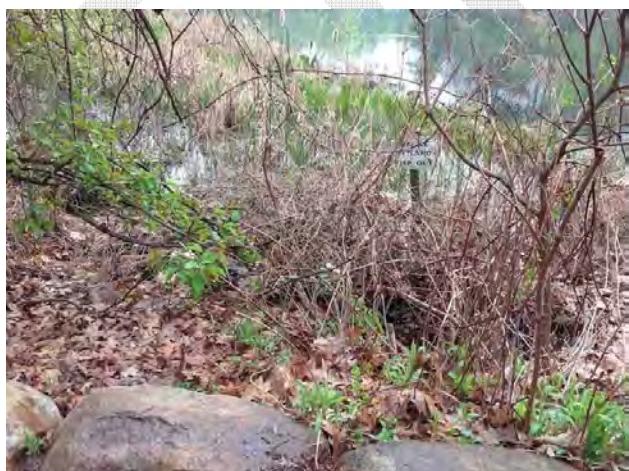
Photo 17

Cautionary signage in the wetlands section of the graded trail is mounted beyond the rocky border and obstructed by vines. Safety and information signage along trail should be inventoried and reposted where it may be beyond viewing distance or obstructed by natural growth. (Photo 17)

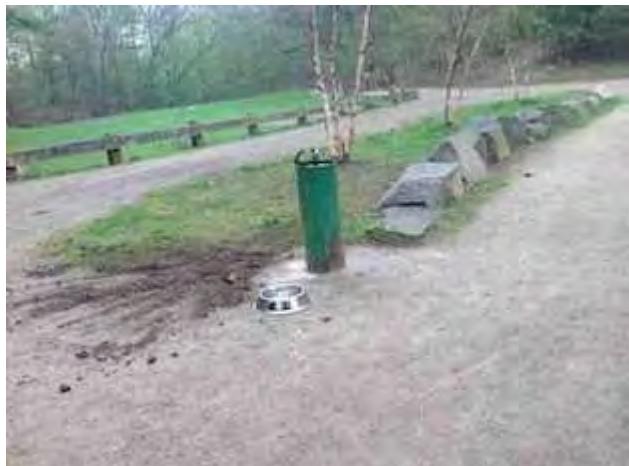
Photo 18

A drinking fountain at the fork in the path may not be in working order. The spout height is accessible and a clear approach and use space is provided. (Photo 18)

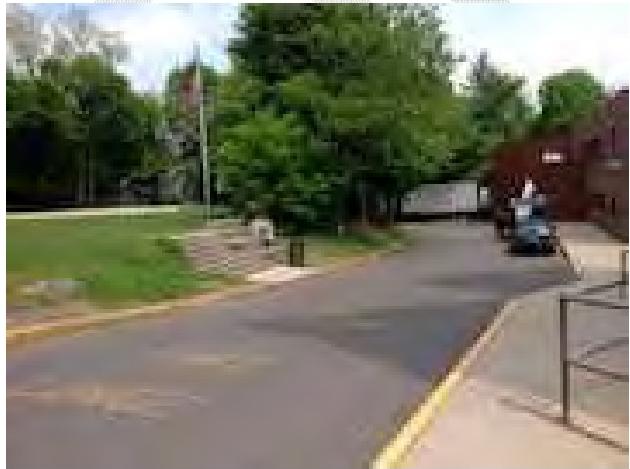
Photo 3

There is no sidewalk provided on the east side of Acton St. from Appleton Pl, and no sidewalk provided on facility side from the Benjamin Road pedestrian sidewalks into the parking lot.¹ (Photo 3)

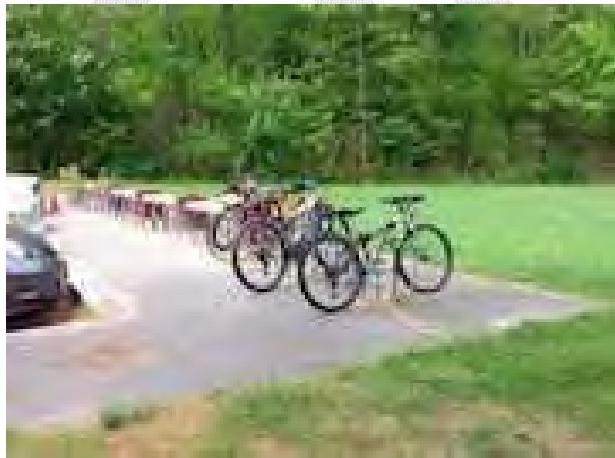
Photo 9

There is one interior walkway between the parking facility and the front strip of the field. This walkway has an uneven surface, excessive cross and run slopes, and is arranged in a cluttered manner at the side that is closest to the accessible parking spaces, and coincident with the general public's path of travel onto the field from the parking lot. (Photo 9)

This walkway does not connect to at least one accessible interior walkway that will provide a firm, level, smooth (non-grassy) continuous route connecting to the perimeter of the field playing areas, the dugout areas, team seating locations, the portable toilet, and the spectator seating along the fence.

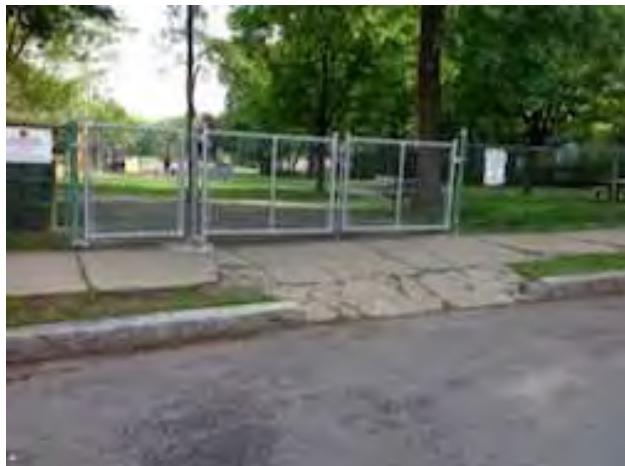
Photo 4

Entrance has 2 fences. Sidewalk apron is cracked and uneven and sidewalk pavement has excessive cross slopes. The entrance needs maintenance. (Photo 4)

Repair cracked sidewalk panels at entry gate.

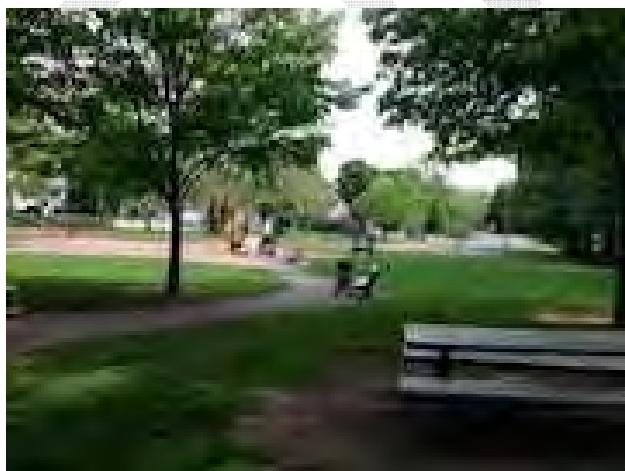
Photo 6

Walkways circulate through the park and around the play areas. The walkways are well graded, smooth and have compliant widths. However, they do not provide a route to all the park features, such as an accessible approach and entry into the play areas, to either side of the court, and to the benches and picnic tables. (Photo 6)

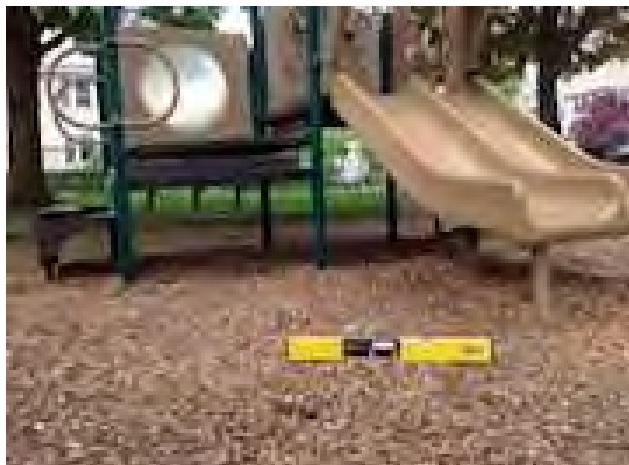
Photo 8

At this time, the loose fill materials are showing excessive cross slopes and holes, which creates uneven conditions and prevents smooth, accessible and unrestricted circulation around the play structures. (Photo 8)

a. If only loose fill ground surface materials are used, a high-frequency maintenance policy needs to be in place to ensure accessibility of ground surface materials in play area use zones through all seasons.

b. If ground surface materials will be replaced: consider adding unitary ground surface materials within the playground areas to provide accessible routes and clear ground spaces to all entry/exit points of ground play elements, including swingsets, spring rockers and play structure.

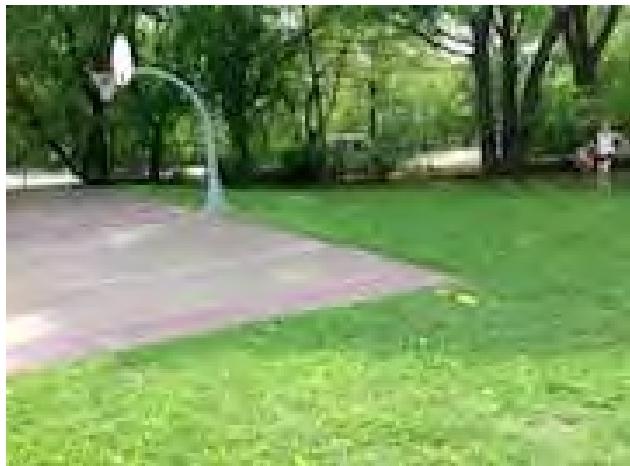
Photo 10

A basketball court is not connected by accessible route to the other areas and elements of the facility, including the entrance. (Photo 10)

Slope measurements taken to one side of the court indicate that it may be feasible to add a graded walkway connecting at least one side of the court to the play area, circulation routes, benches and tables, and entrance gate.

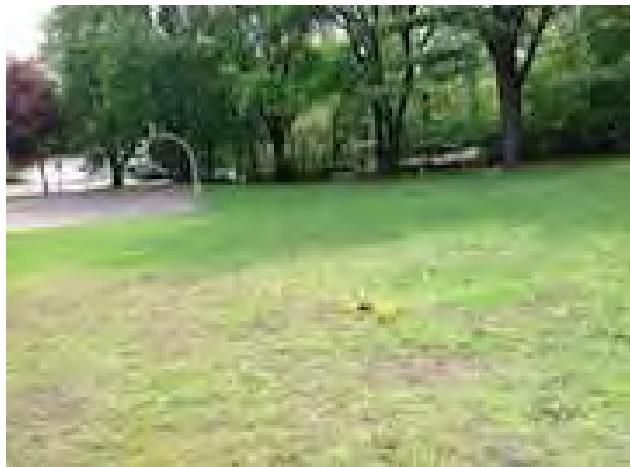
Photo 11

There are no compliance issues requiring attention for the open grassy area. It appears feasible to provide at least one skinned field path leading to one side of the court from the paved circulation walkway. (Photo 11)

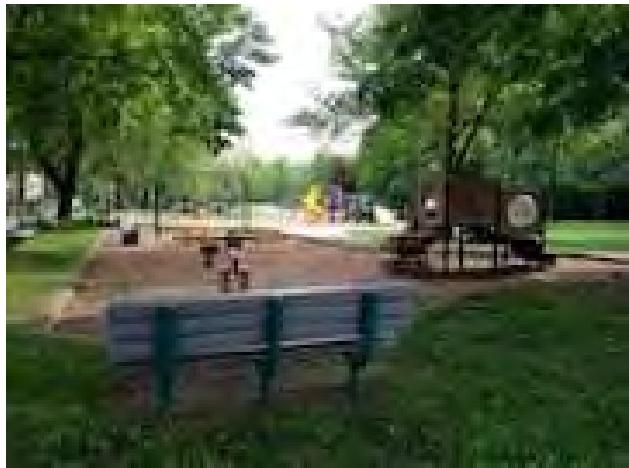
Photo 13

At least one bench should be adjacent to a clear space that is level, firm and at least 32 inches wide and 48 inches in length, allowing for integrated shoulder to shoulder wheelchair seating. (Photo 13)

1. See Recommendations for Access to Facility Areas, *Interior Walkway*
2. At least one side of at least one bench along an accessible route, ensure that a clear ground space with minimum 36 inches width and 48 inches length is available for integrated wheelchair seating. This clear area should adjoin, and not overlap, with accessible route,

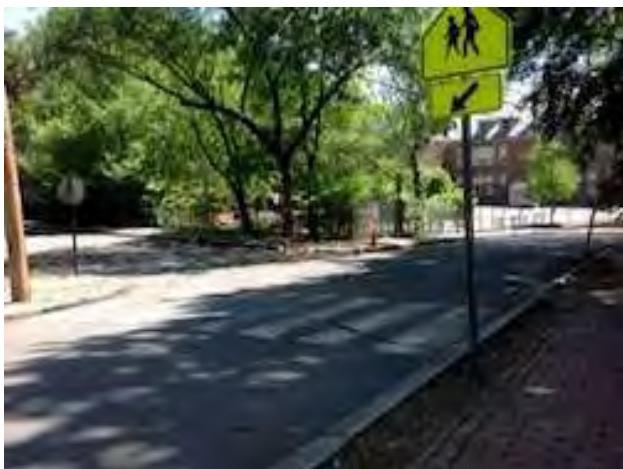
Photo 2

Crosswalk at Irving and Academy St. is highly inaccessible with steep slopes. The Pedestrian Safe Crossing sign is mounted on an unsafe, not smooth completely inaccessible brick sidewalk. There is no curb ramp at either end of the crosswalk. On the school side, the curb cut is unusable, with no flared sides, no accessible slopes, and no bottom landing. (Photo 2)

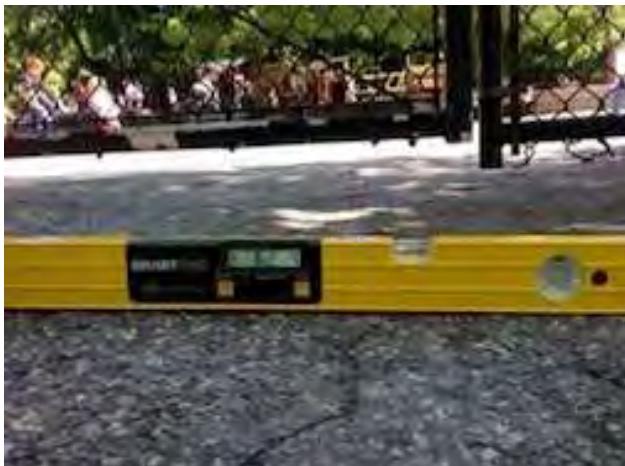
Photo 4

Sidewalks from Pleasant St. & Irving to facility have excessive cross slopes. and require repair around the perimeter of facility. (Photo 4)

Reconstruct sidewalks and curb ramps from Public transit stop to intersection of Pleasant & Irving St. At curb ramp nearest APS pole, replace apex curb ramp with blended curb ramp oriented towards east.

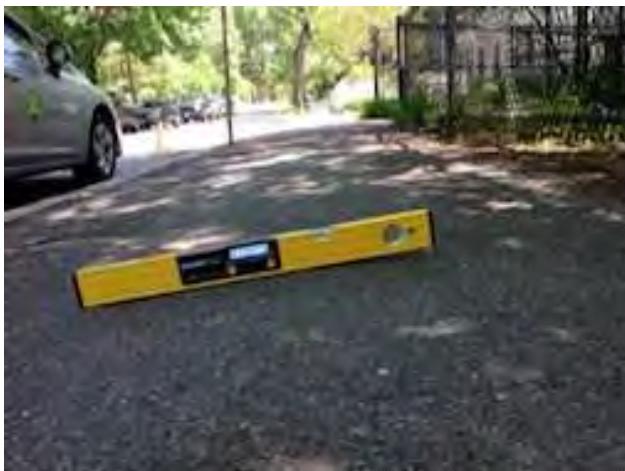
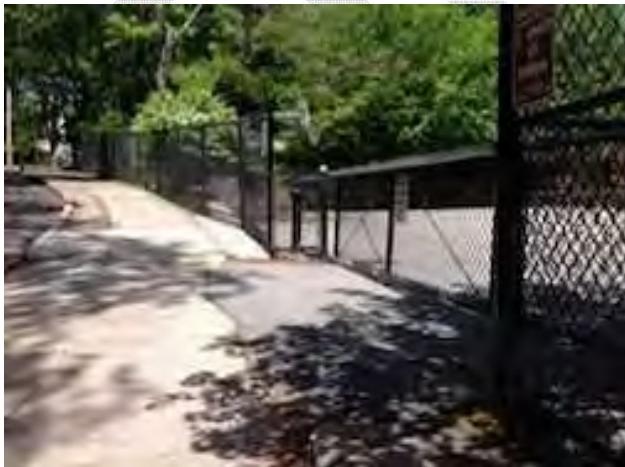
Photo 6

Both points of entry have excessive cross slopes. The sidewalk and entry panels near the gate are in disrepair. (Photo 6)

1. Replace driveway apron at Irving St. entrance with sidewalk that blends to 5% at entrance within pedestrian zone. Repair cracks in asphalt and ensure that ground materials match levels. (about 4 S.F.)
2. Reconstruct recessed entryway from curb to gate at Academy St. entrance. (about 6 S.F.)

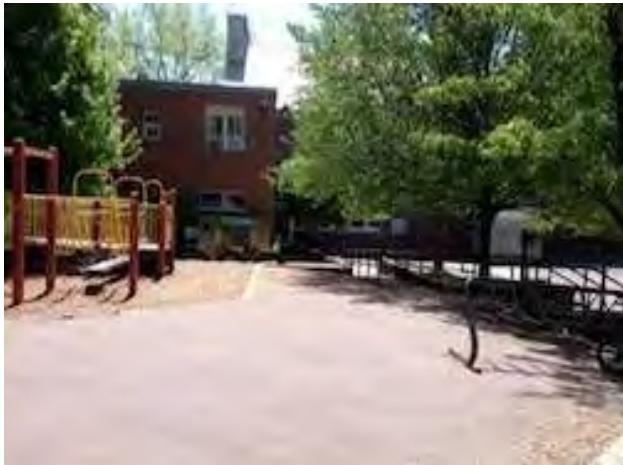
Photo 8

Walkways do not connect with play areas because the borders surrounding play areas is not level with either the loose fill in the play areas and the walkway hardtop. (Photo 8)

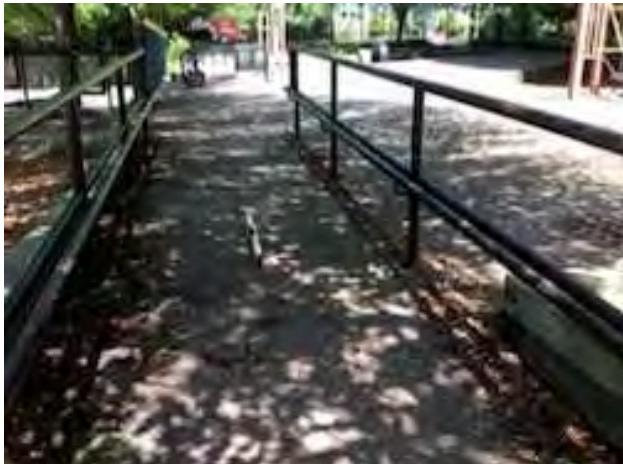
Photo 10

Ramp has excellent accessible slopes and accessible handrails. There is some slight disrepair due to age at the bottom and top landings. (Photo 10)

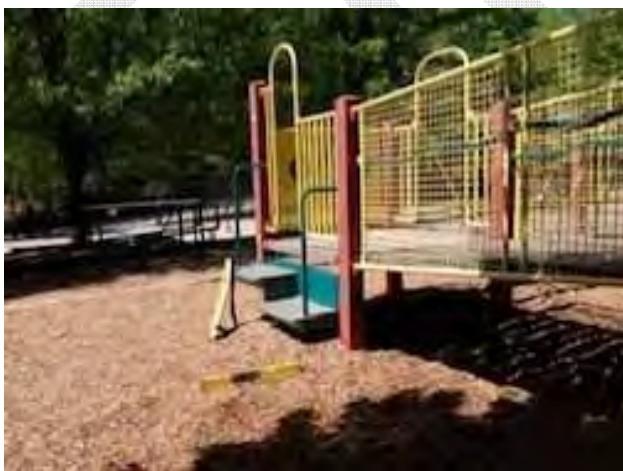
Photo 12

Although the play areas closer to the ramp include some accessible play structures, the loose fill ground surface does not hold accessible slopes. Cross slopes are over 5% near transfer steps, and at other entry/exit points within the play areas. (Photo 12)

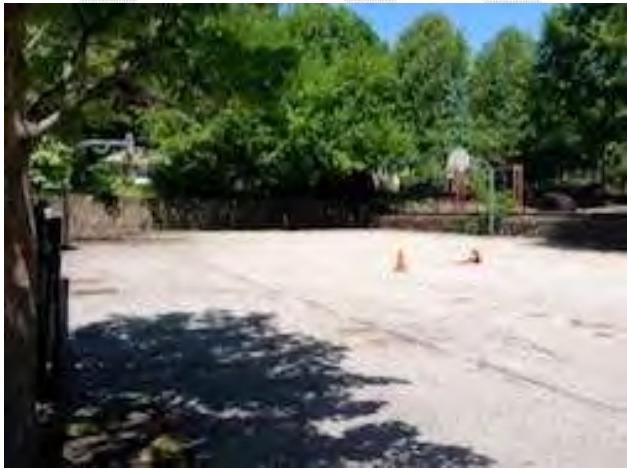
Photo 15

A full basketball court is provided at the entry gate from Irving St. This area also includes two accessible benches. (Photo 15)

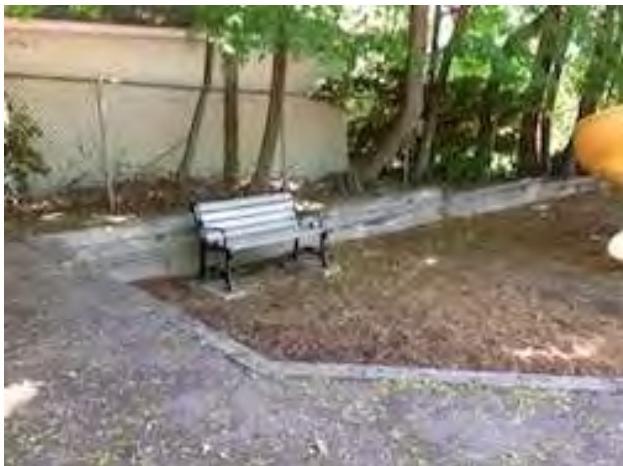
Photo 16

There is one bench at the playground area with a backrest and armrests. It is set into the recessed play area. This bench is inaccessible because it is not approached with an accessible route; and it is sitting on loose fill ground surface materials that are not holding an accessible cross slope. (Photo 16)

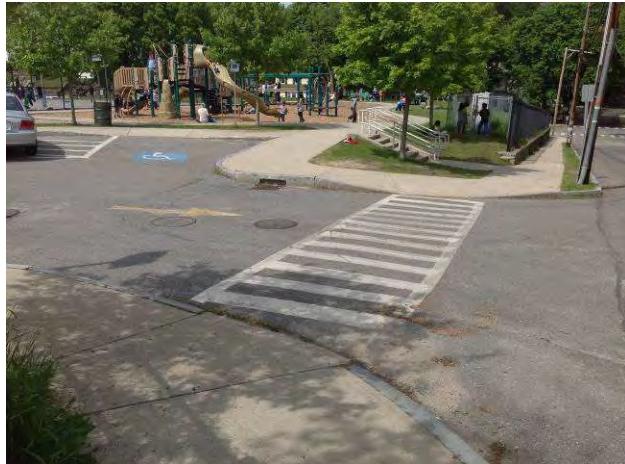
Photo 1

Sidewalks and curb ramps nearby Peirce School Park are in good condition. However, curb ramps provided on both ends of the crosswalk at the intersection of Newland Road and the driveway near the playground are not accessible because level top landings are not provided. (Photo1)

Repair both curb ramps at the intersection of Newland Road and the driveway near the playground (total of 2 curb ramps).

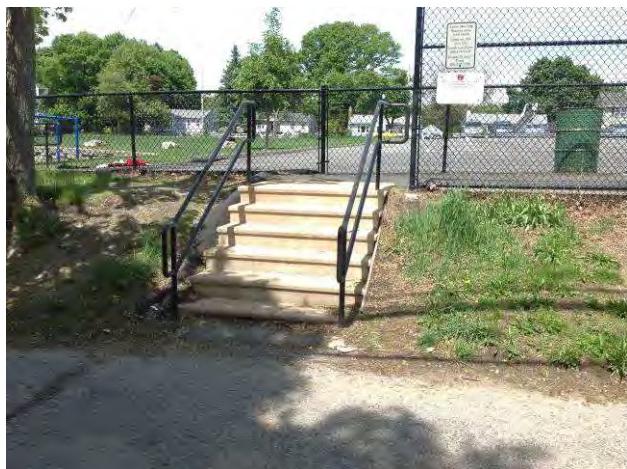
Photo 2

This facility has five points of entry: two stairways and a ramp along Pheasant Avenue and an at-grade access at the parking lot and a gate opening leading to the grassy field on Mountain Avenue. At the bottom of the stairway closest to the playground, the surface is in need of maintenance and is not slip-resistant. (Photo 2)

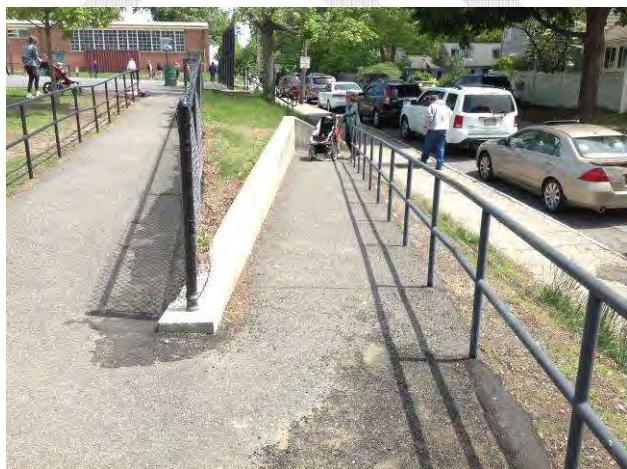
Photo 3

Twenty five feet west of the stairway, a ramp with missing railing on one side and a protective edge on the other side connects the sidewalk to the facility. Additionally, the surface at top of ramp is in need of maintenance. (Photo 3)

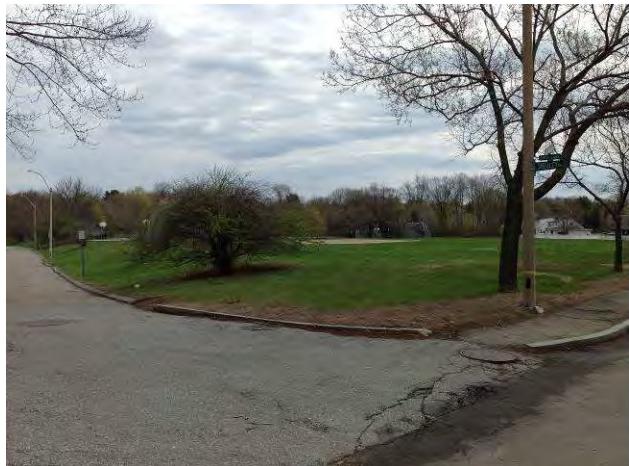
Photo 1

The sidewalk along Wadsworth Road is in poor condition. Not only are a few sections deteriorated but also the sidewalk has excessive cross slopes and sediments from adjacent areas that can make the ground surface slippery. Additionally, no sidewalk is offered along Shelley Road, except for the short section of sidewalk at the entry point near the playground. (Photos 1 and 3)

Repair sidewalk along Shelley Road (about 25 feet) and extend it to the intersection of Wadsworth Road in order to create an accessible route to the nearby public transit stop (about 500 feet).

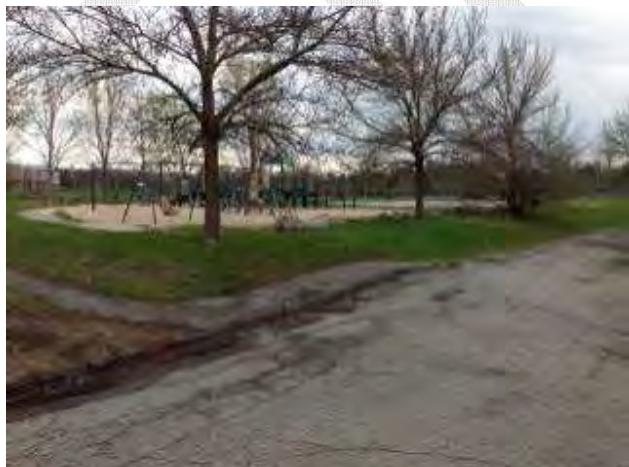
Photo 3

With exception of the point of entry near the playground on Shelley Road, there are no other clear points of entry in this facility. This point of entry is in poor condition and lacks a curb ramp. (Photo 3)

- 1 Crosswalks and Curb Ramps:** Install curb ramps at the intersection of Wadsworth and Shelley Roads and install one curb ramp near the point of entry at Shelley Road.

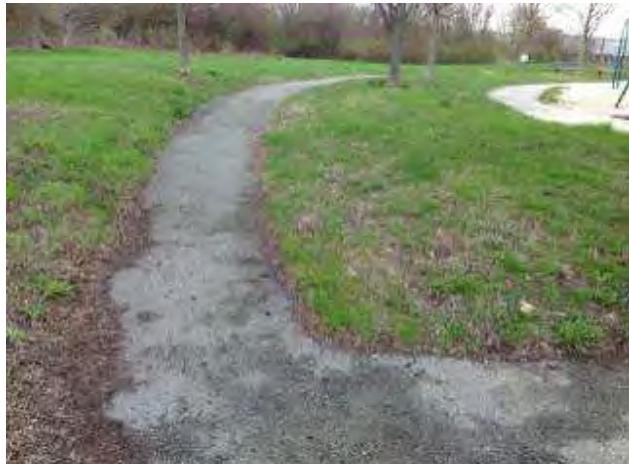
Photo 4

Although an asphalt walkway is provided between the point of entry at Shelley Road and certain features within this facility, it has excessively slopes near the street (11%) and deteriorated ground surfaces near the courts. (Photos 4 and 5)

Re-grade and repair the asphalt walkway so that it is free of tripping hazards and that running slopes are no greater than 5% and cross slopes are no greater than 2% (about 275 feet).

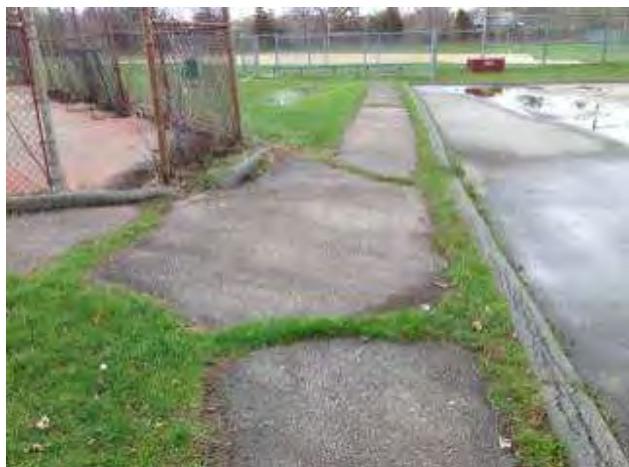
Photo 5

Because asphalt curbs are located along the perimeter of the tennis courts and the basketball court, no accessible route is provided to these courts. (Photos 5 and 6)

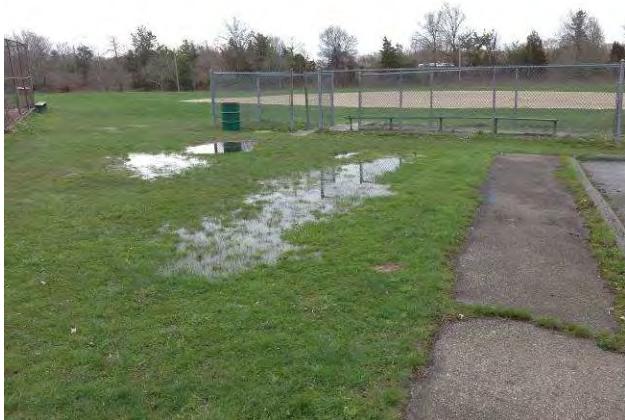
Photo 7

Additionally, the asphalt walkway does not extend beyond the basketball court and no accessible route is provided to the baseball field and batting cages on the South side of the facility. (Photos 7 and 8)

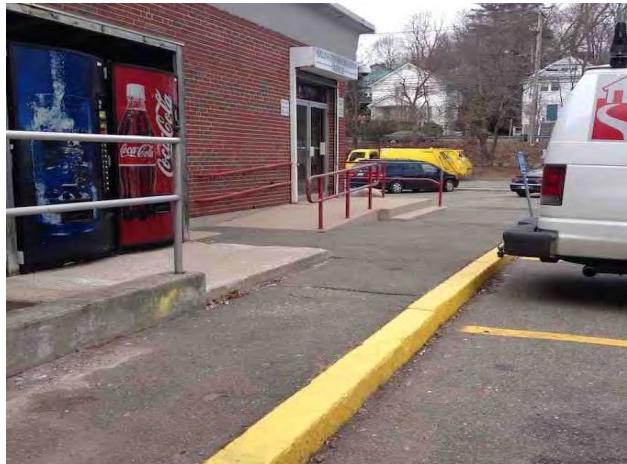
Photo 1

Although the ramp that leads to the office entrance has compliant slopes, it is missing the required edge protection on one side and it does not adjoin an accessible route – Please see Sports Complex, Site Arrival Survey in Part C - Evaluation of Facilities for information regarding Crosswalk, Curb Ramps, and Sidewalks. Additionally, two vending machines are located adjacent to the office entrance. Such appliances are inaccessible because they are located on a platform and not on an accessible route and controls are out of reach ranges. (Photo 1)

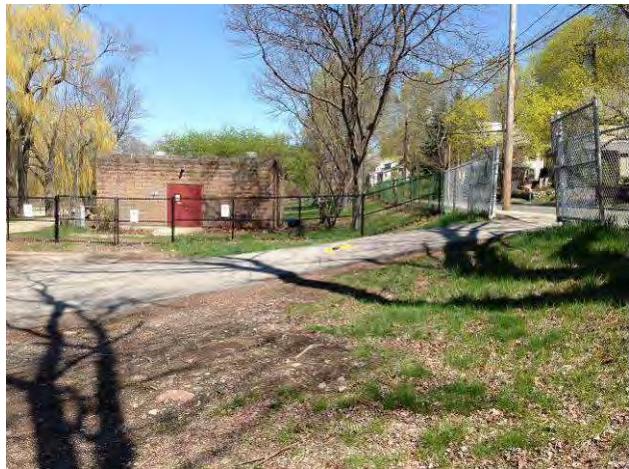
Photo 2

On Lowell Street, both asphalt driveways that lead to the parking lot are also used for pedestrian access. The asphalt driveway closest to the beach is in poor condition and has excessively slopes (20%). (Photos 2 and 3)

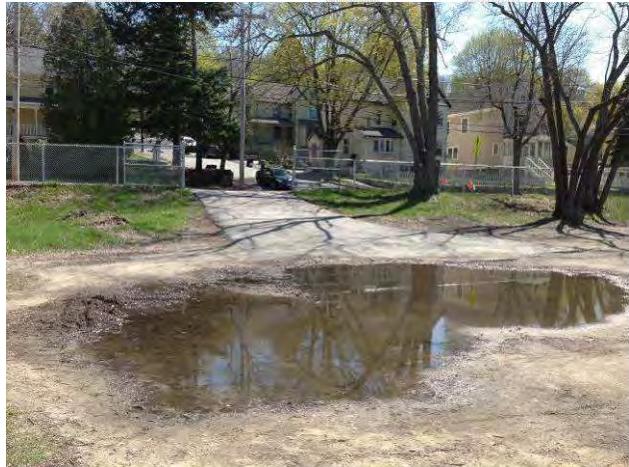
Photo 3

This facility has a large unpaved parking lot off of Lowell Street. Although two *ad hoc* spaces designated as accessible are provided near the gated entrance to the beach, they do not meet any of the minimum requirements for accessibility. (Photo 3)

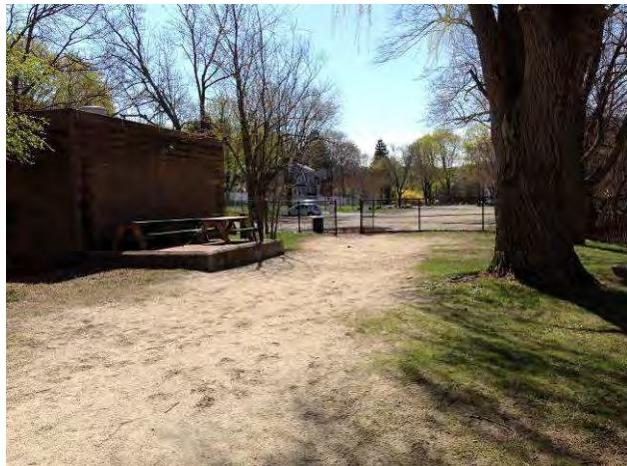
Photo 4

A sand path is provided along the entire facility. This path is not accessible because it is uneven and unstable, especially near benches and trees. Despite a concrete walkway is provided near the water's edge, it is not connected to an accessible route. (Photos 4 and 5)
